# Intergranular Corrosion-Fatigue Failure of Cobalt-Alloy Femoral Stems

## A FAILURE ANALYSIS OF TWO IMPLANTS\*

BY JEREMY L. GILBERT, PH.D.<sup>†</sup>, CHRISTINE A. BUCKLEY, M.S.<sup>‡</sup>, JOSHUA J. JACOBS, M.D.<sup>‡</sup>, KIM C. BERTIN, M.D.<sup>§</sup>,  
AND MICHAEL R. ZERNICH, M.D.<sup>¶</sup>, CHICAGO, ILLINOIS

*Investigation performed at the Division of Biological Materials, Northwestern University, Chicago*

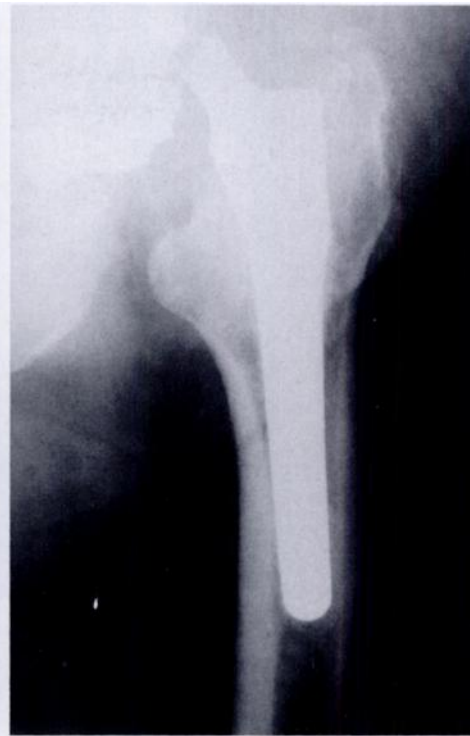
FIG. 1-B

**CASE 1.** A 112-kilogram, 175-centimeter-tall man had a primary total hip replacement with the insertion of a PCA prosthesis (Howmedica, Rutherford, New Jersey) without cement, at the age of sixty-seven years, for the treatment of severe osteoarthritis (Fig. 1-A). Seventy months postoperatively, the patient was seen by one of us (M. R. Z.) because of the sudden onset of pain in the hip. Before this, the hip had been asymptomatic. The patient had had an active lifestyle and had frequently played golf. Radiographs revealed a fractured prosthetic neck (Fig. 1-B).

Fig. 1-B: Seventy months postoperatively, the fractured prosthetic neck is clearly seen just distal to the head-neck junction.

At the revision, the prosthetic fracture was easily identified, and the prosthetic head was free in the joint. The femoral component was extremely well fixed to the adjacent bone and was difficult to extract. On removal, an extensive amount of bone was adherent to the device, and a fracture of the femoral shaft was sustained intraoperatively. The acetabular component was well fixed. A long-stem prosthesis was inserted without cement and with the use of strut allografts. The patient was doing well two years postoperatively.

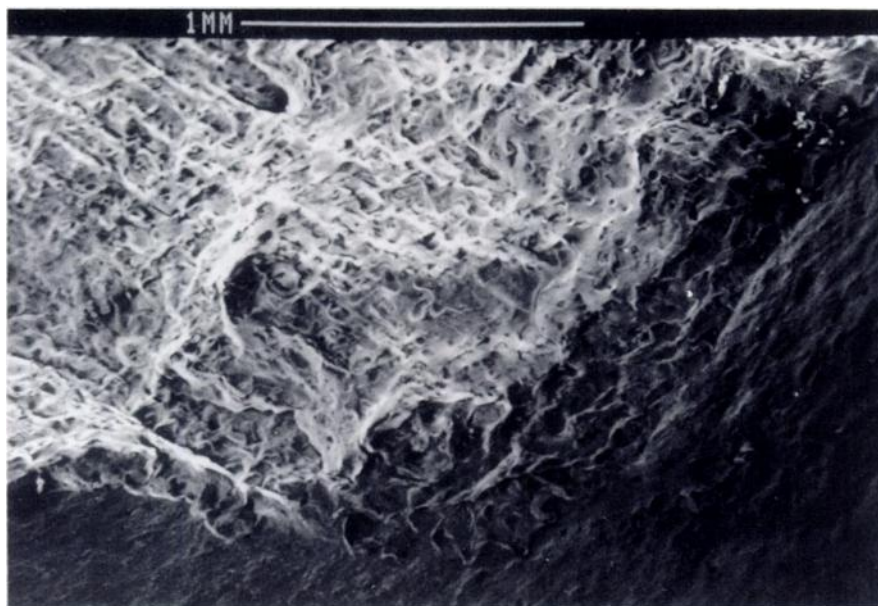
FIG. 3

Case 1. Low-magnification micrograph of the edge of the fracture surface, showing the intergranular nature of the fracture. The fracture surface at the superior initiation point is at the upper left, and the free surface of the neck is at the lower right. Intergranular pores are present on the fracture surface ( $\times 41.8$ ).

For Case 1, a low-magnification scanning electron micrograph of the superolateral fracture surface (Fig. 3) showed that the fracture surface had a smooth appearance, with small pores or craters. As will be subsequently shown, this appearance was due to interconnected and isolated porosity as well as a corrosive attack at the

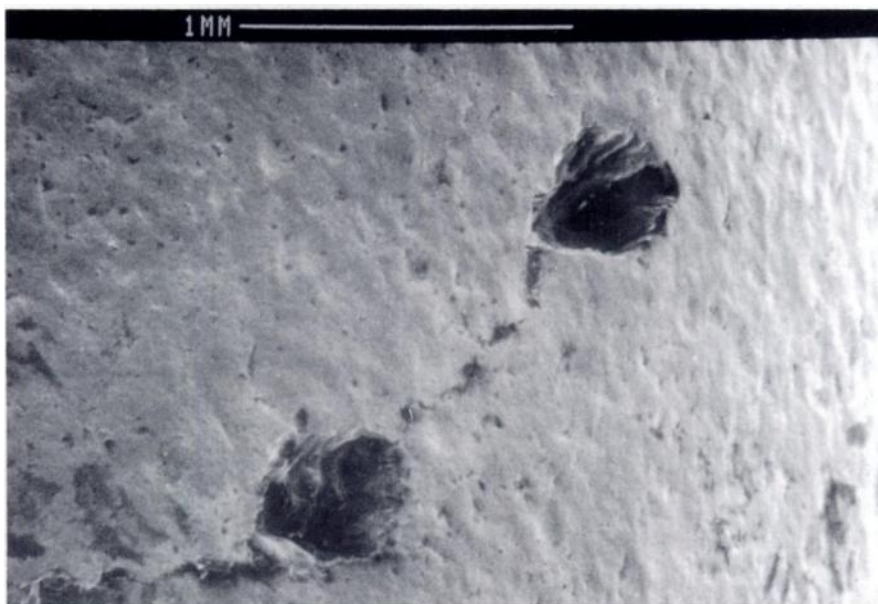
FIG. 4

Case 1. Low-magnification micrograph of the free surface, showing pits that have formed because of egression of small surface grains. These small grains are located at the larger grain boundaries ( $\times 40.8$ ).

Intergranular cracks were seen to connect several pits that had formed on the outer surface of the prosthesis (Fig. 4). These pits, which were as large as 500 micrometers in diameter, were small surface grains that had fractured about their boundaries and had egressed out of the surface microstructure. These small egressed grains were typically located at the larger-grain boundaries.

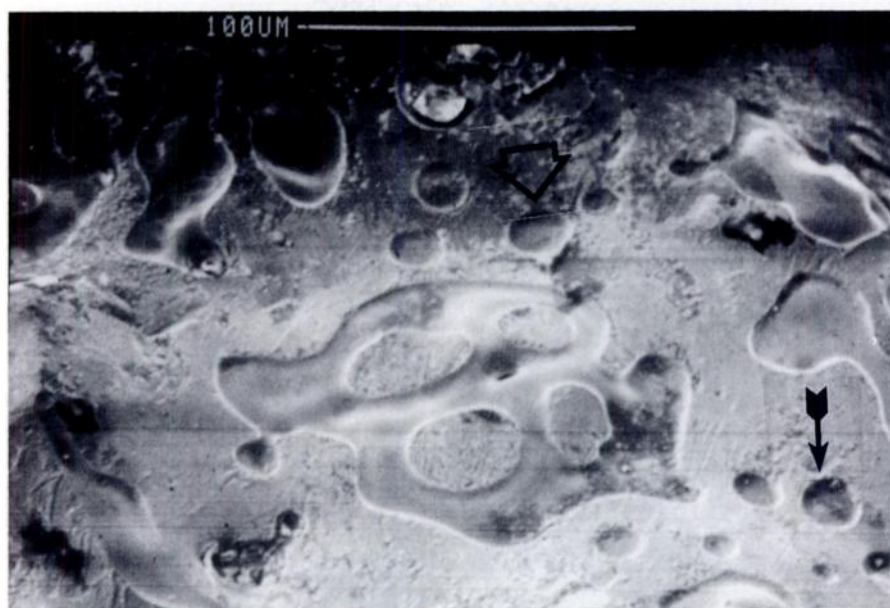
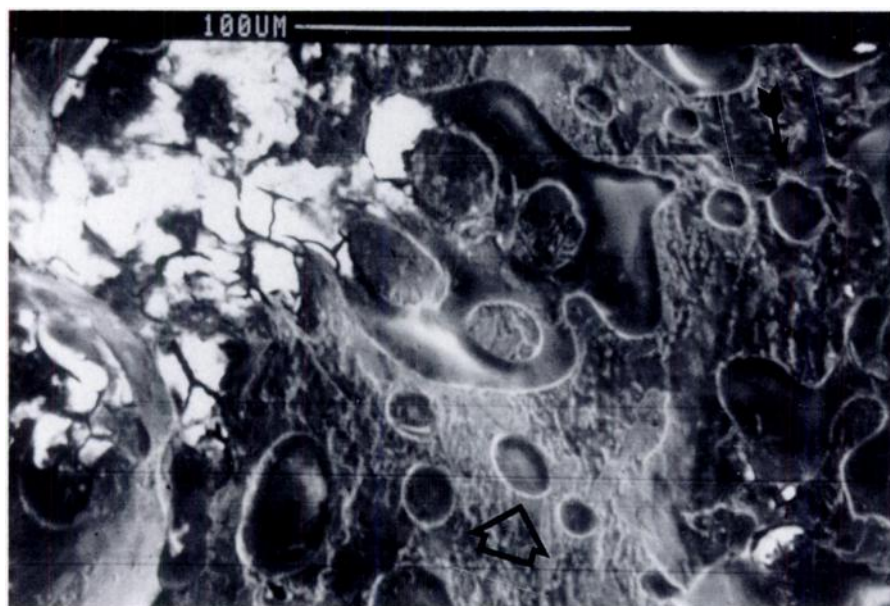
Figs. 5-A and 5-B: Case 2. Micrographs of the opposing fracture surfaces, showing the smooth and rough regions. Note the mirror symmetry, from top to bottom, of the two figures. The pores (arrows) appear to be isolated by the rough regions, indicating that they were present before the fracture of the prosthesis. Some non-conducting debris, which is rich in chromium and most likely consists of segregated carbides at the grain boundaries, can be seen (Fig. 5-B, upper left) ( $\times 406$  [Fig. 5-A] and  $\times 400$  [Fig. 5-B]).

the lateral free surface (that is, at the site at which the fracture had initiated), showed two general regions of interest: one smooth and one rough. The rough regions appeared to be deformed, to show clear evidence of pitting corrosion attack, and to indicate that the grain boundaries in these regions were initially intact but had subsequently been attacked by the combined effects of the repeated cyclic loading and the intergranularly penetrating fluid. The smooth regions appeared to be slightly depressed from the rough regions and were irregular in shape. These smooth regions may have been due either to an initial intergranular corrosive attack,

This analysis was carried out for Case 2. Micrographs with mirror symmetry, from top to bottom, of the same region on opposing fracture surfaces (Figs. 5-A and 5-B) showed several isolated, roughly circular pores that had no signs of being interconnected but were, instead, only surrounded by a rough fracture surface.

This suggests that the pores were not created by fluid penetrating along the grain boundaries but were instead generated during the manufacture of the prosthesis.

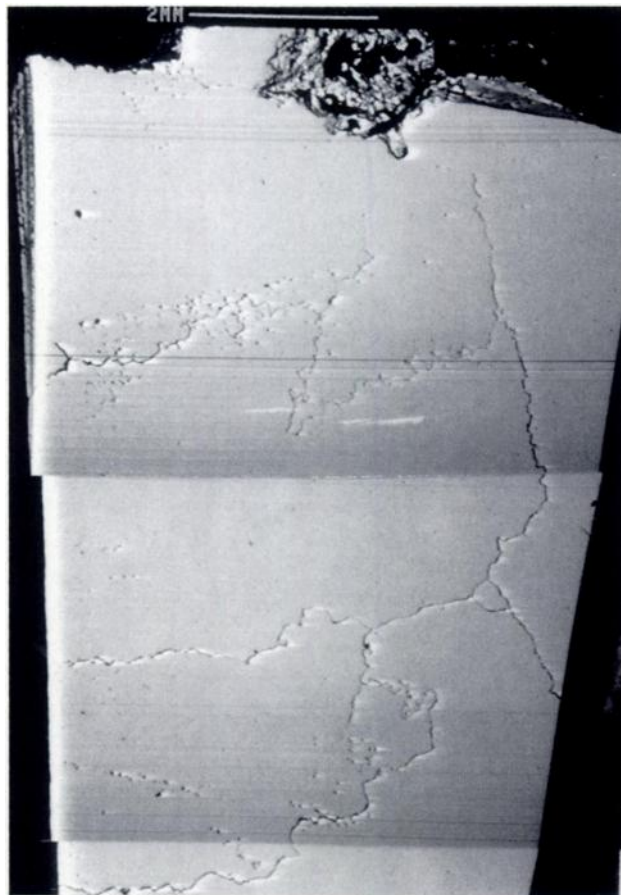
FIG. 6

Case 1. Montage of the cross section, with the fracture surface at the top and the laterosuperior surface at the left, showing intergranular cracks throughout the neck. The fracture surface follows the grain boundaries of the material.

The sections from the necks revealed clear evidence of corrosive penetration of fluid intergranularly into the microstructure. This intergranular attack was adjacent to the fracture surface and was continuous with an intergranular attack emanating from the head-neck taper region. In a montage of a sectioned surface from Case 1 (Fig. 6), the outline of the grains was seen clearly and was the result of intergranular attack and porosity. For Case 2, the neck-head taper junction was seen clearly and had been extensively attacked at the grain bound-

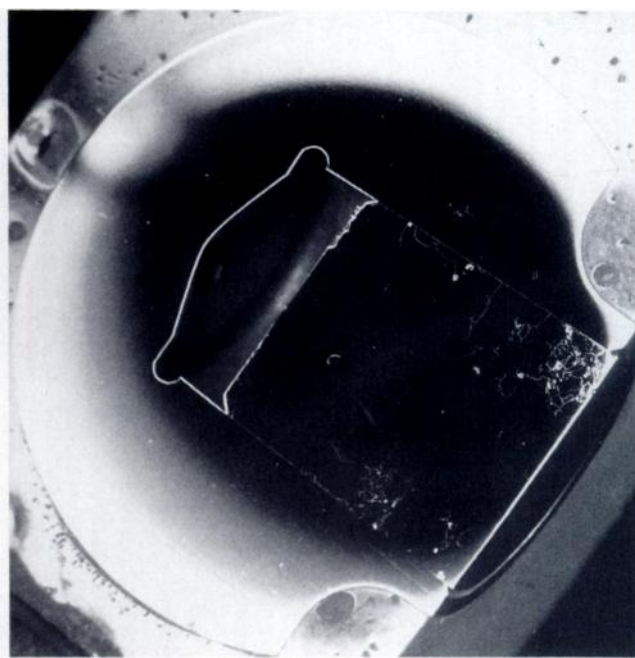
FIG. 7

Case 2. Optical photograph showing intergranular cracking at the taper-free surface junction. This cracking, which is localized at the taper junction, appears to travel down into the neck toward the region of the fracture surface.

aries (Fig. 7). The intergranular attack seemed to be concentrated at the superior and inferior surfaces of the neck at the taper-free surface junction.

Furthermore, an intergranular corrosive attack was shown to have occurred in the neck region, at the lateral and medial sites of the head-neck taper junction, and this intergranular attack had penetrated several millimeters into the microstructure. In Case 2, the intergranular cracking was focused at the taper junction and had penetrated into the microstructure.
